June 28, 2019
File No. 262018.063

Subject: Department of Natural Resources Washington Geological Survey,
School Seismic Safety Assessment Project, Contract No. AE 410 -
Seismic Evaluation for **Shaw Island School District**

School Buildings Evaluated in the Shaw Island School District

Shaw Island, Shaw Island School, Admin/RR Building

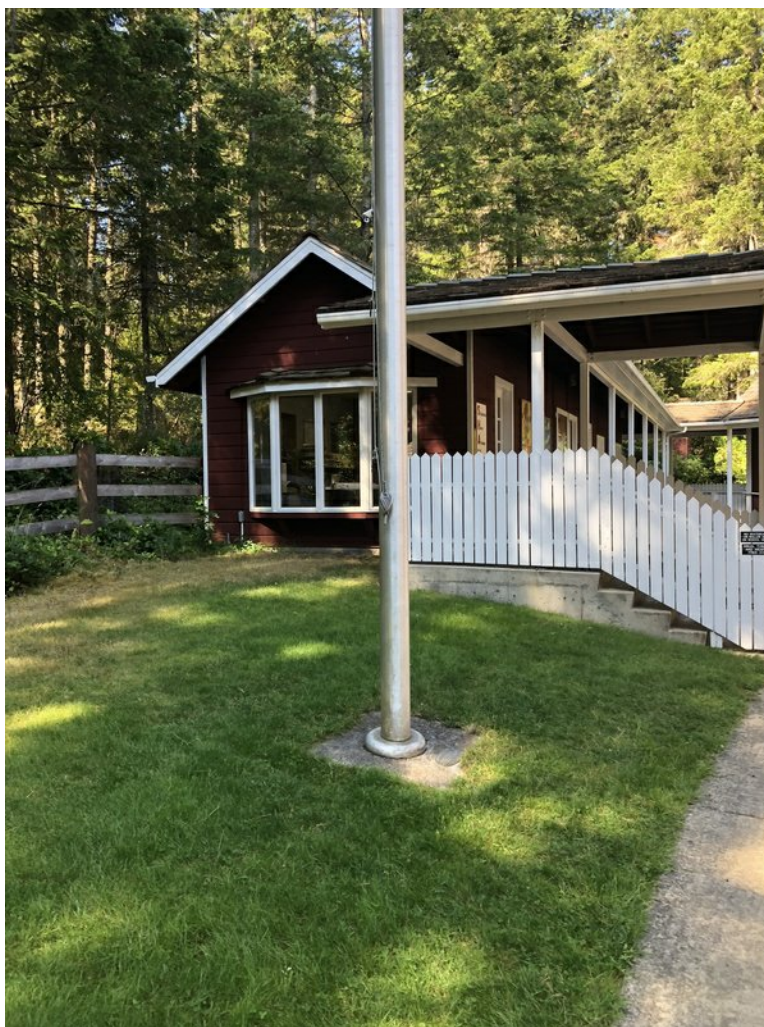
Figure 1-1. Building exterior showing outside flag pole and covered walkway.

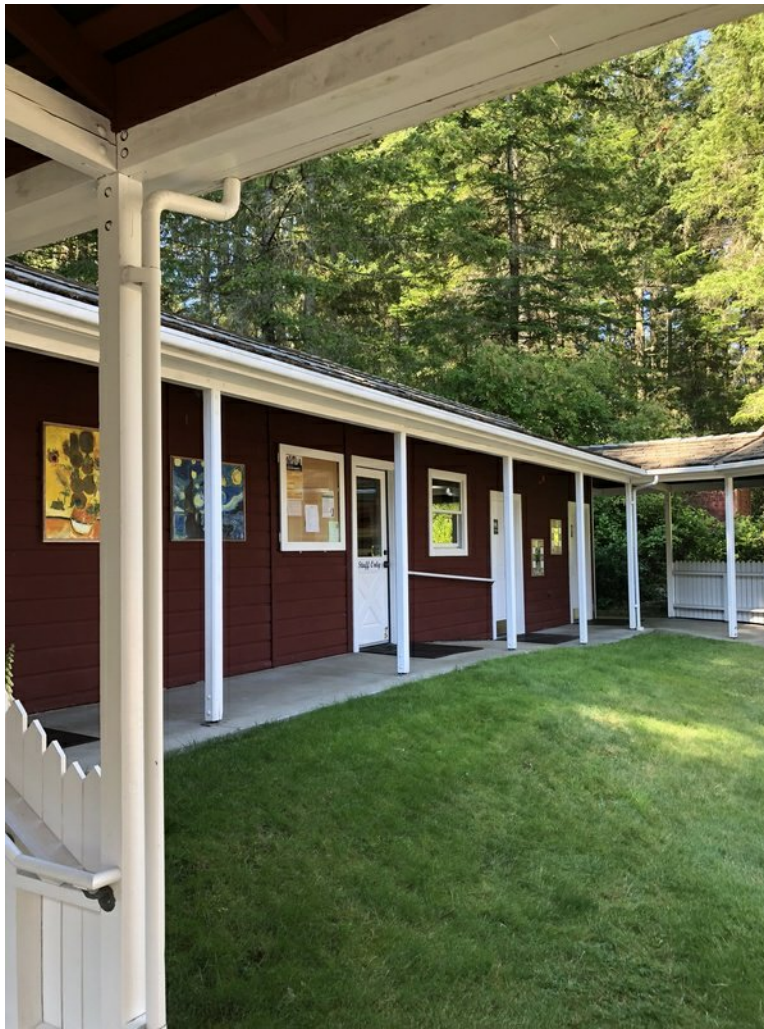
Figure 1-2. Building exterior showing exterior awning and walkway.

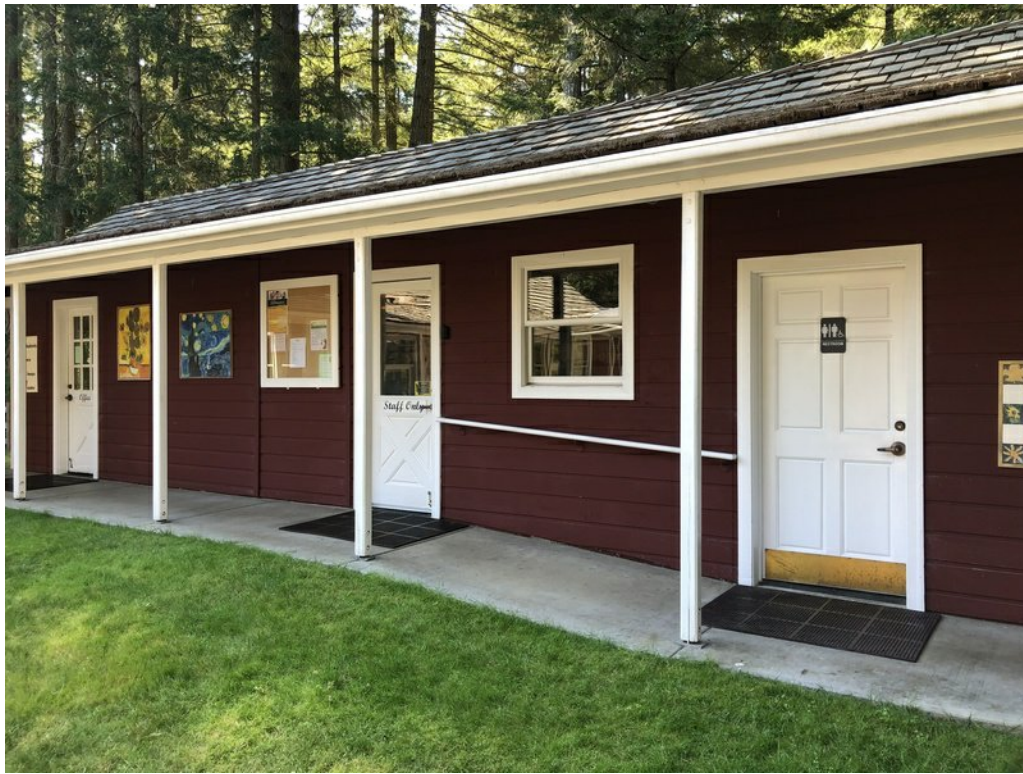
Figure 1-3. Building exterior.

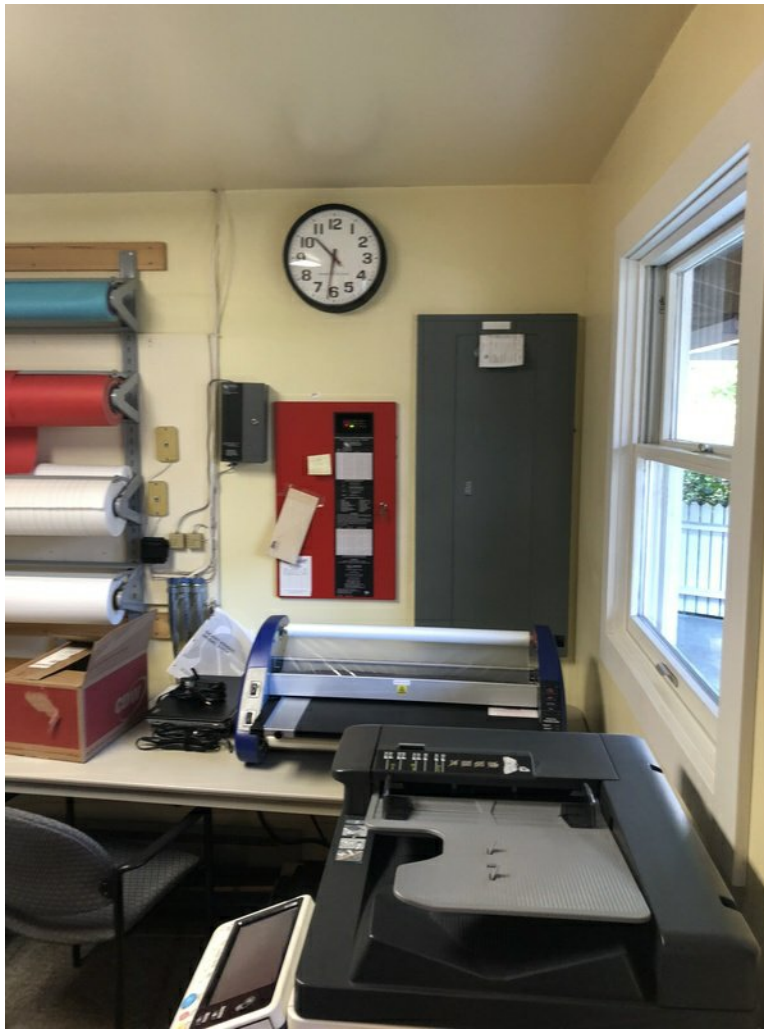
Figure 1-4. Building interior.

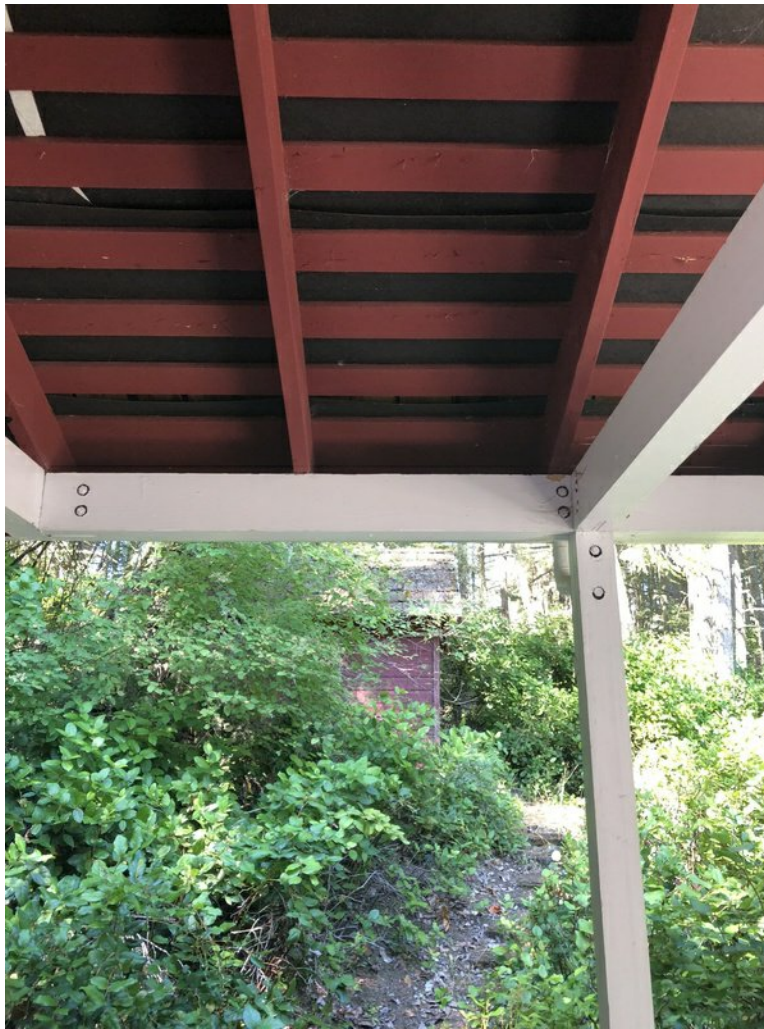
Structural System	Description
Structural Roof	The roof system is comprised of cedar shake roofing supported by 1x wood members spanning between the roof framing members. The roof framing members are typically supported by exterior wood bearing walls. The construction of the roof does not provide consistent roof diaphragm to resist lateral loads.
Structural Floor(s)	The floor system of the building is 4" slab on grade.
Foundations	The building is supported by perimeter concrete strip foundations.
Gravity System	Wood framed roof and floor system supported by exterior wood framed bearing walls on concrete strip foundations.
Lateral System	The buildings lateral system is comprised of a wood-framed roof with a flexible roof diaphragm that spans between the exterior wood shear walls. The wood framed roof is constructed of cedar shingles over 1x framing that runs transverse to the main roof joists. The 1x wood framing that supports the shingles is gaped and thus will provide limited lateral stiffness and capacity.

Figure 1-5. Under side of roof, note the 1X framing members that support the shingles above and that these members are gapped.

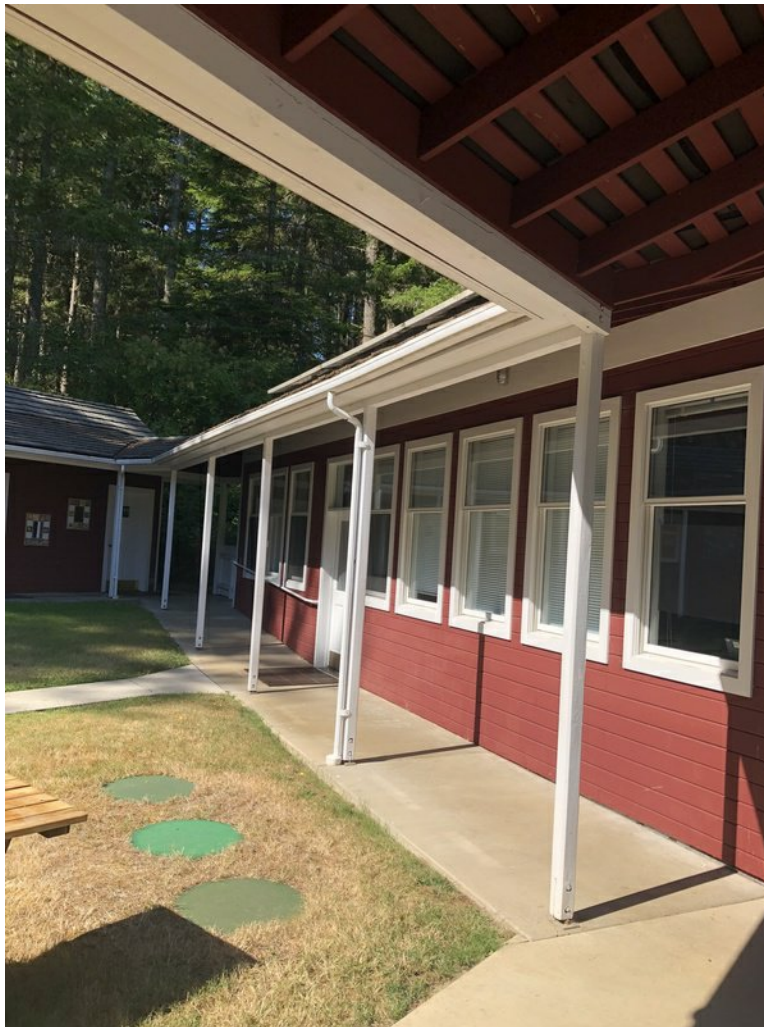
Figure 1-1. Building exterior

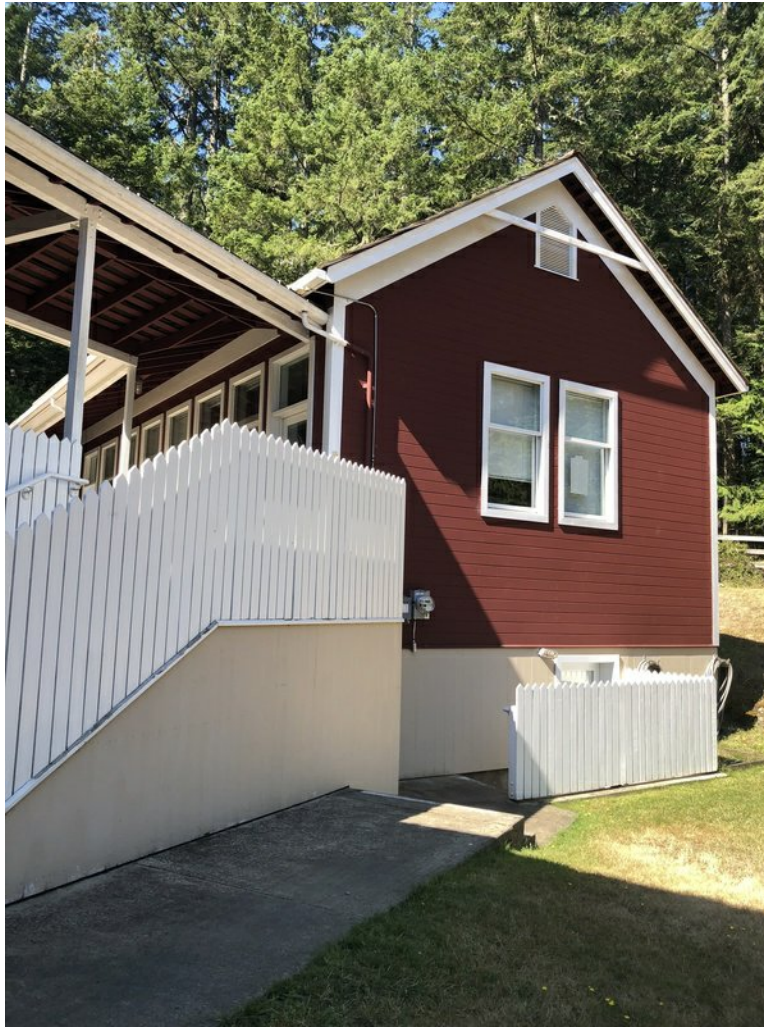
Figure 1-2. Building exterior, note the entrance to the partial basement and crawl space.

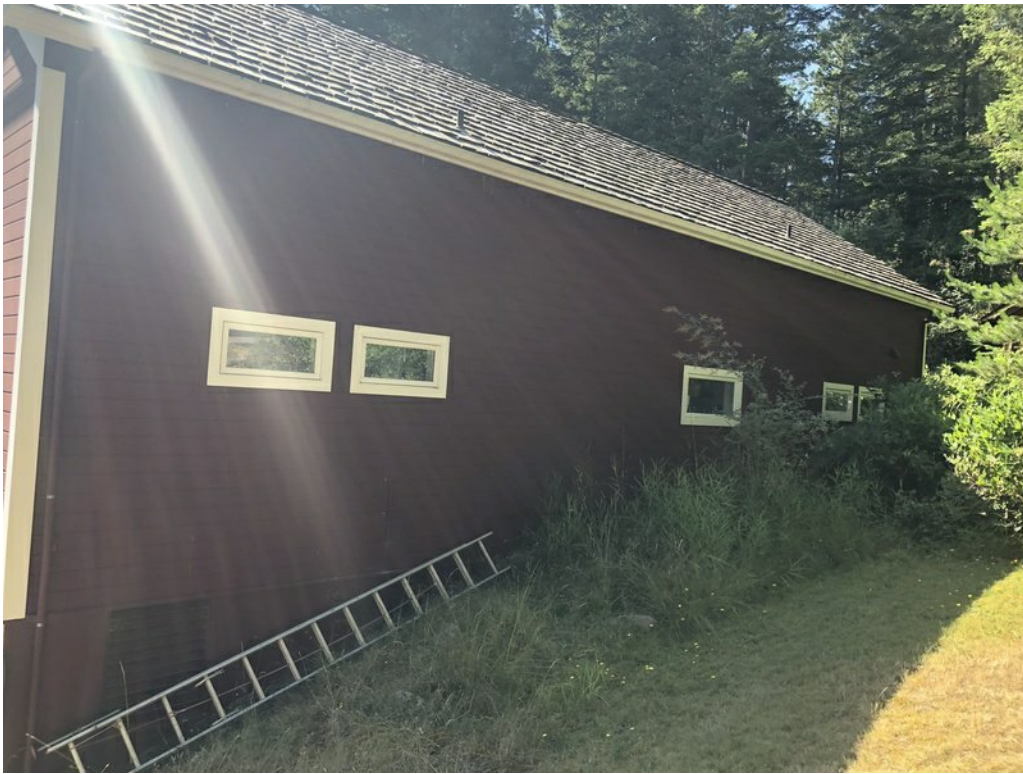
Figure 1-3. Building exterior

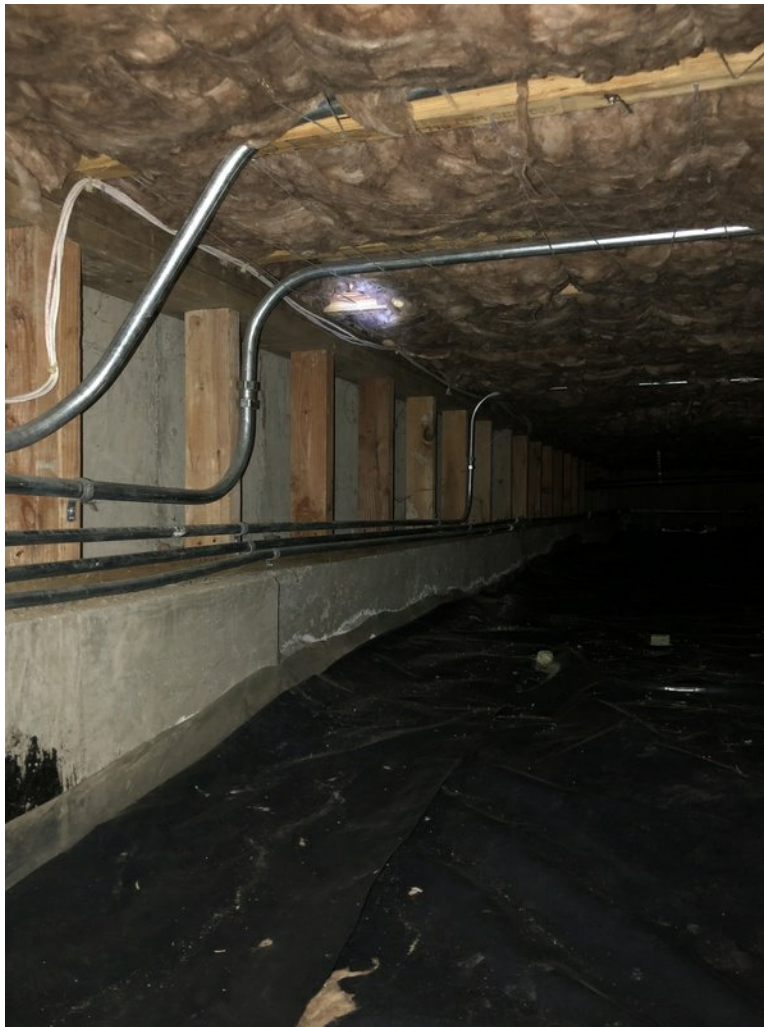
Figure 1-4. Building crawl space

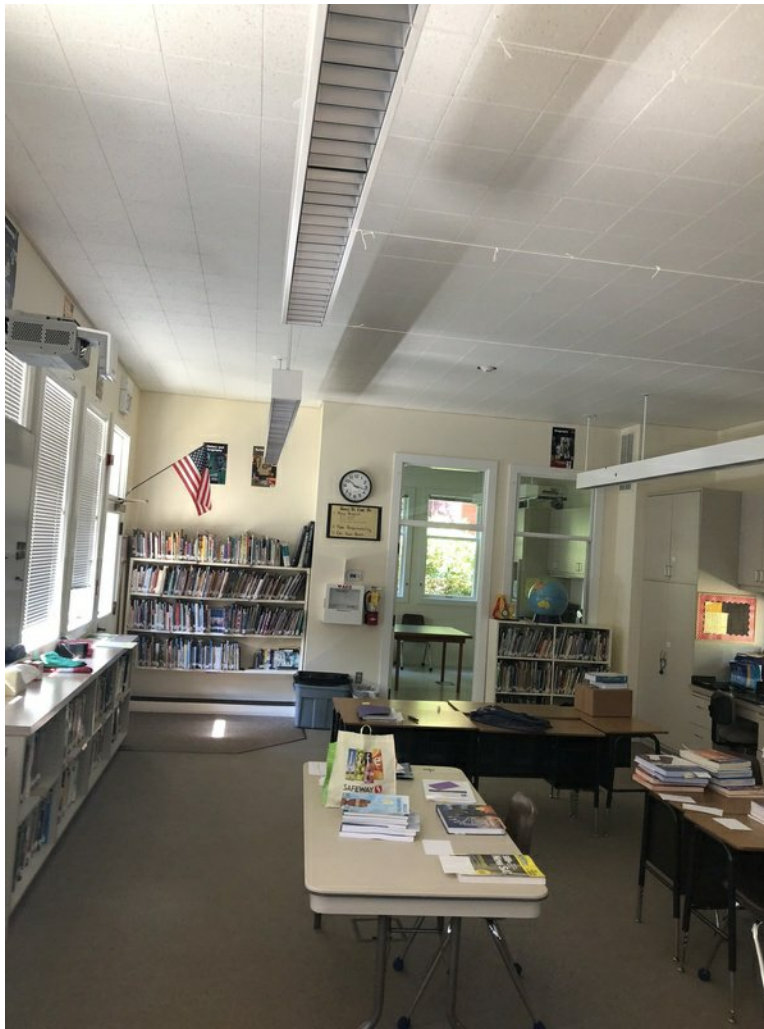
Figure 1-5. Building interior

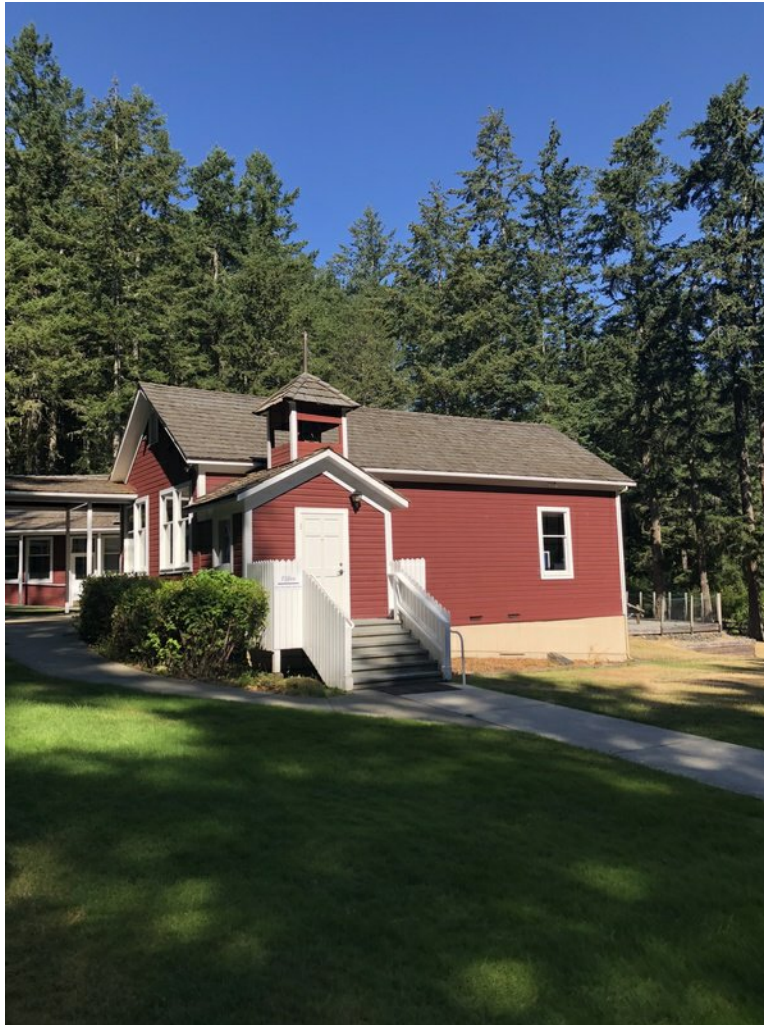
Figure 1-1. Building exterior

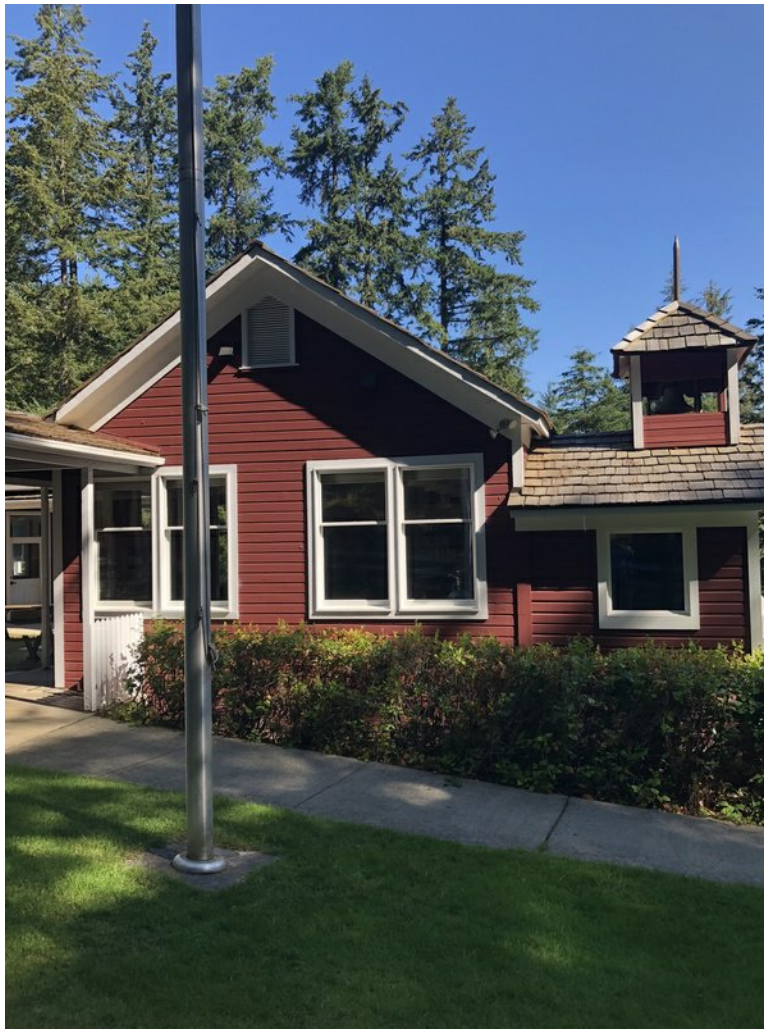
Figure 1-2. Building exterior

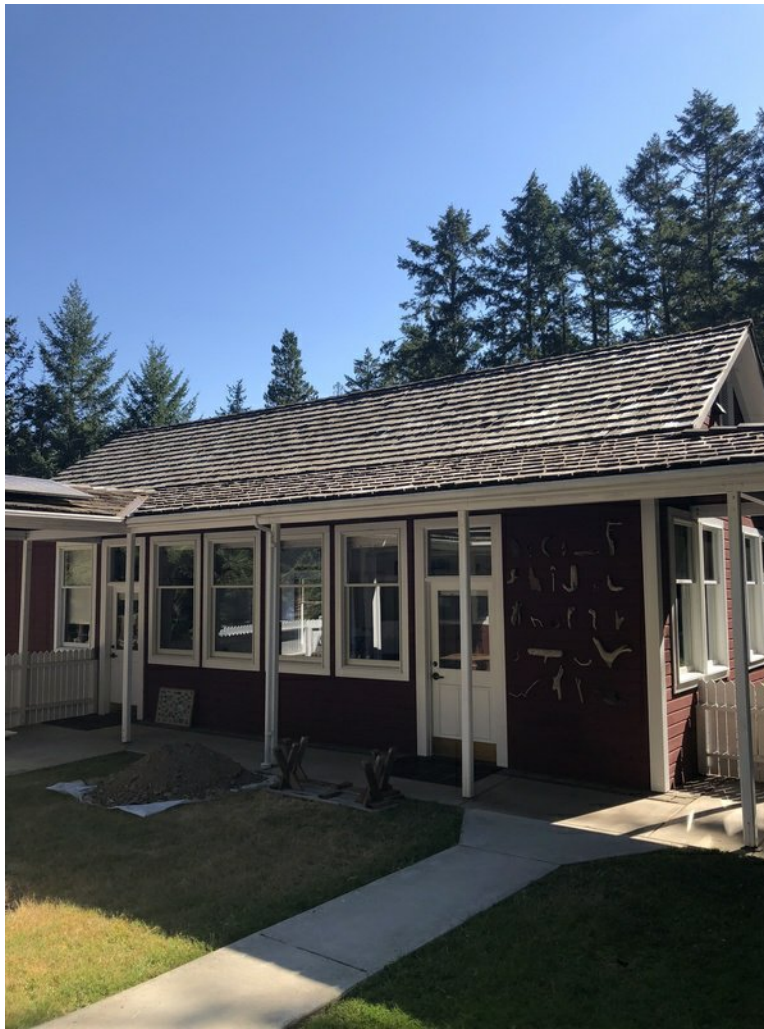
Figure 1-3. Building exterior showing covered walkway

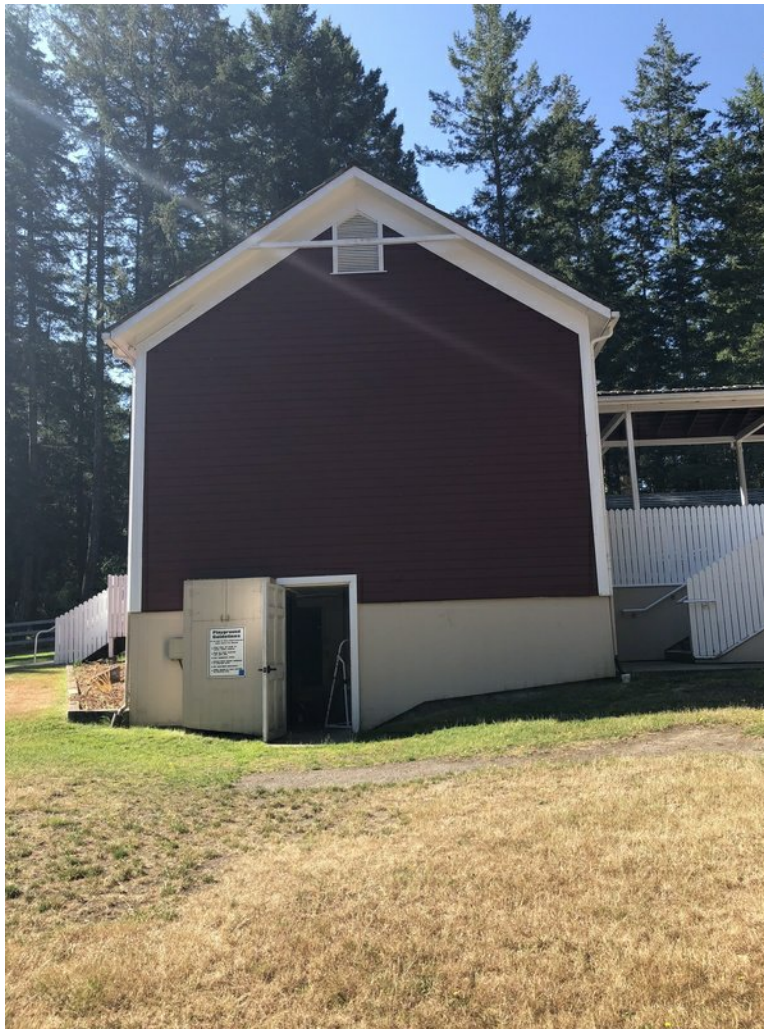
Figure 1-4. Building exterior, entrance to partial basement and crawl space

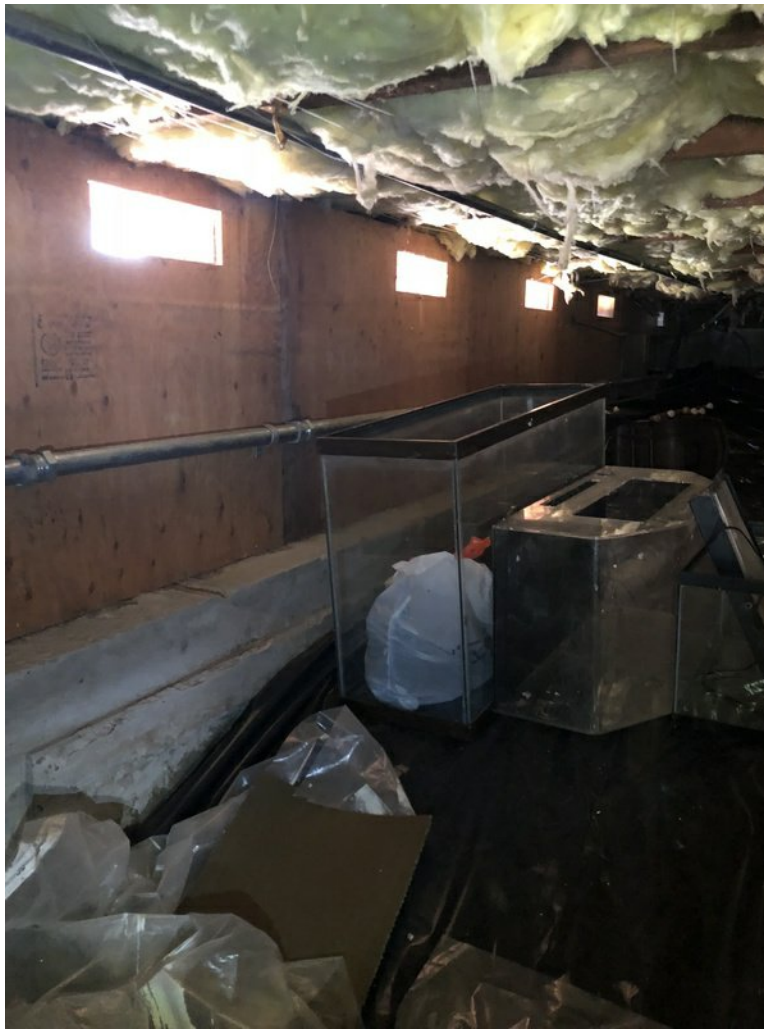
Figure 1-5. Building crawl space, note that plywood has been installed at the perimeter basement walls and that the plywood is attached to the wood framing with staples.

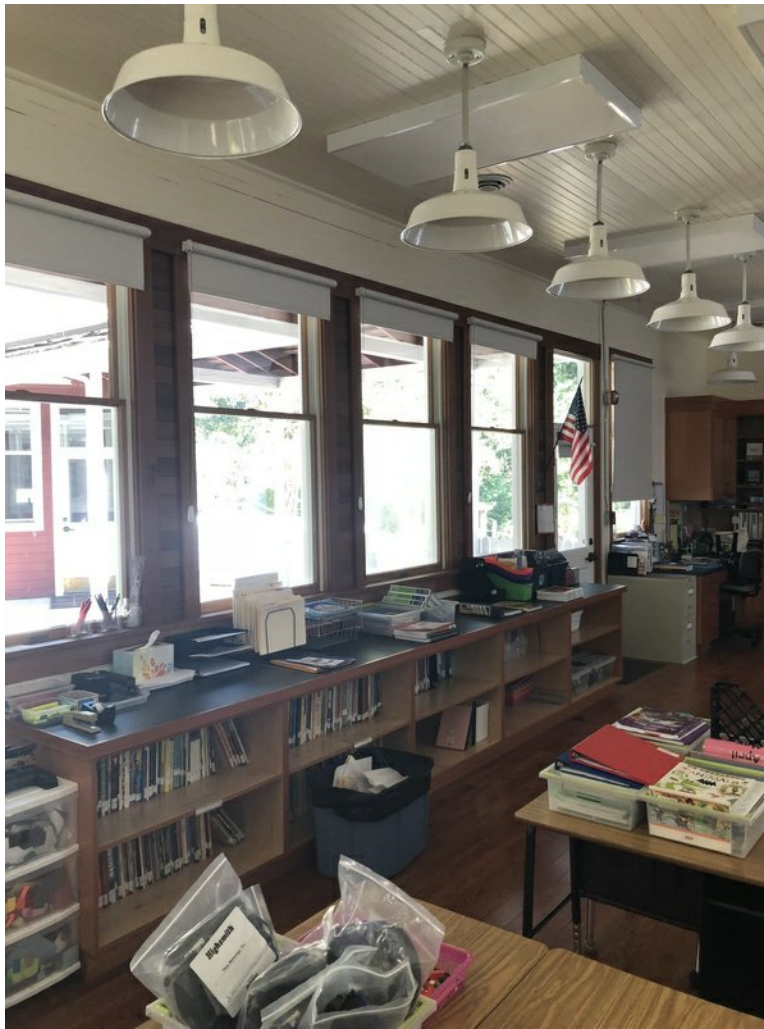
Figure 1-6. Building interior classroom.
